# **Test Report**

## ANSI/CAN/UL9540A

# Test Method for Evaluating Thermal Runaway Fire Propagation in Battery Energy Storage Systems [Unit Level]

Test object / Model: Lithium-ion Rechargeable Battery System

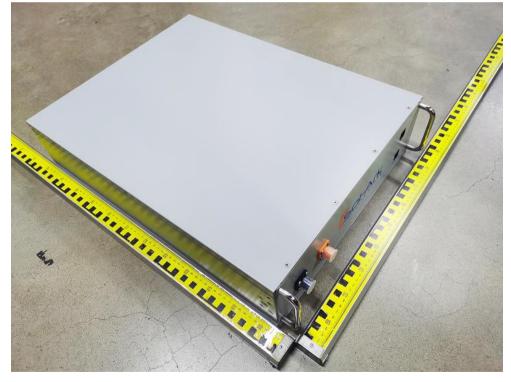
Figure 2a: View 01 of battery module.

Model:	L3 HV-5.1kWh		
Manufacturer:			
Nominal capacity:	100 Ah		
Nominal voltage:	51.2 V		
Module designation:	1P16S		
Maximum charge current:	100 A		
Maximum discharge current:	100 A		
Maximum charge voltage:	57.6 V		
Cut-off Voltage:	45 V		
Charge temperature range:	0°C to 55°C		
Discharge temperature range:	-20°C to 55°C		
Module configuration:	16 Lithium ion cells	in 16S cased by metal enclosure	
Enclosure material:	Painted metal		
Weight:	Appr. 44 kg		
UL 1973 compliant:	⊠ Yes / □ No	Reference: Contract No: 802329, issued by SGS	
UL 9540A report provided:	⊠ Yes / □ No	Reference: SGS report No. CQES230900045801

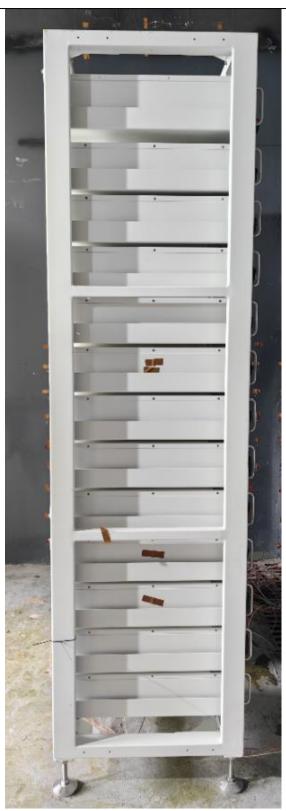
Figure 3b. External view 02 of battery system

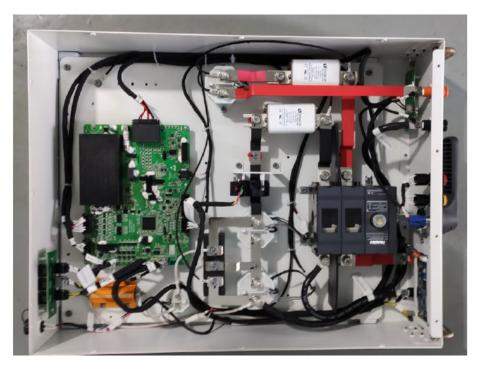
Figure 3d. Internal view of battery management system controller

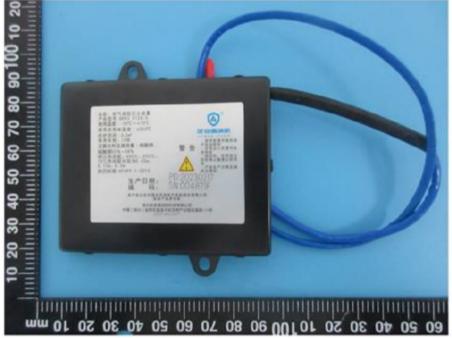
Figure 3f View of Aerosol unit (Internal side of battery pack)

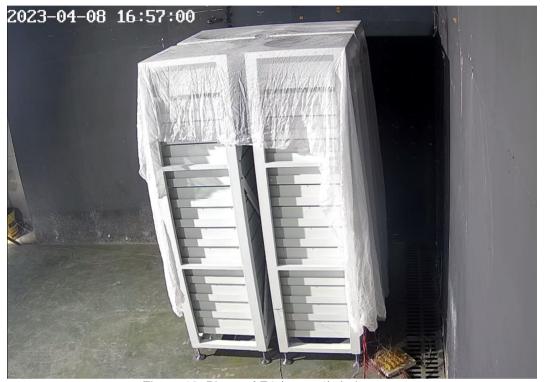
Figure 12. Photo of E1 (event 1) during test.

Time (HH: MM: SS)	Relative Time (HH: MM: SS)	Event ID	Event	Description	Photo Reference
16:57:00	0:00:00	E1	E1 Test Start		Figure 12
16:58:00	0:01:00	E2	Heater 1 and Heater 2 Energized		
17:57:45	1:00:45	E3	First Release	Smoke release observed from initiating battery system enclosure.	Figure 13
18:24:42	1:27:42	E4	Second Release	Smoke release observed from initiating battery system enclosure.	Figure 14
20:18:47	3:21:47	E5	Test Termination

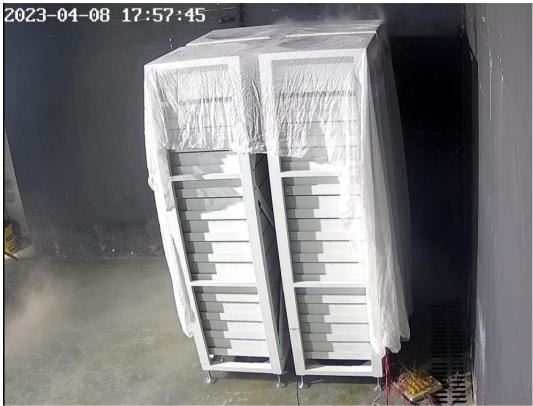
Figure 13. Photo of E3 during test.

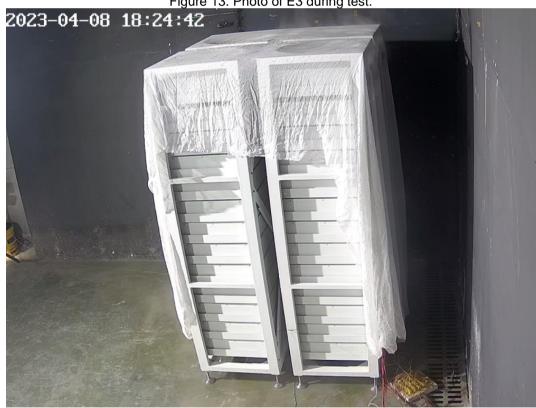
Figure 14. Photo of E4 during test.

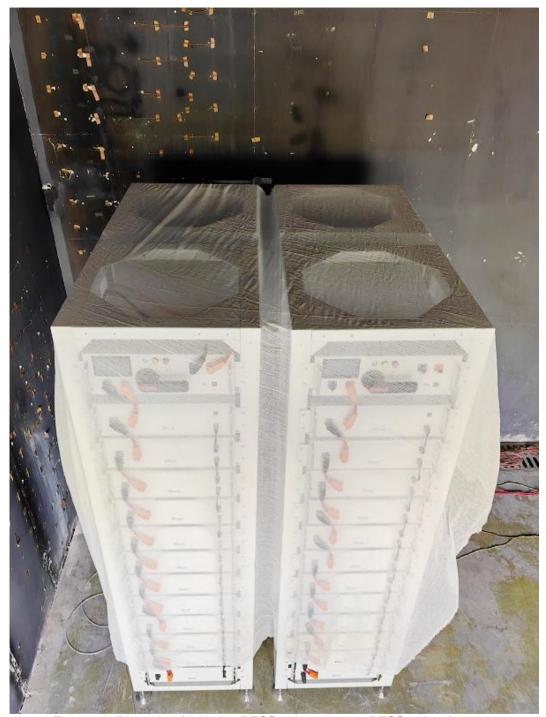
Figure 15. Photo 01 of initiating BESS unit and target BESS units after test.

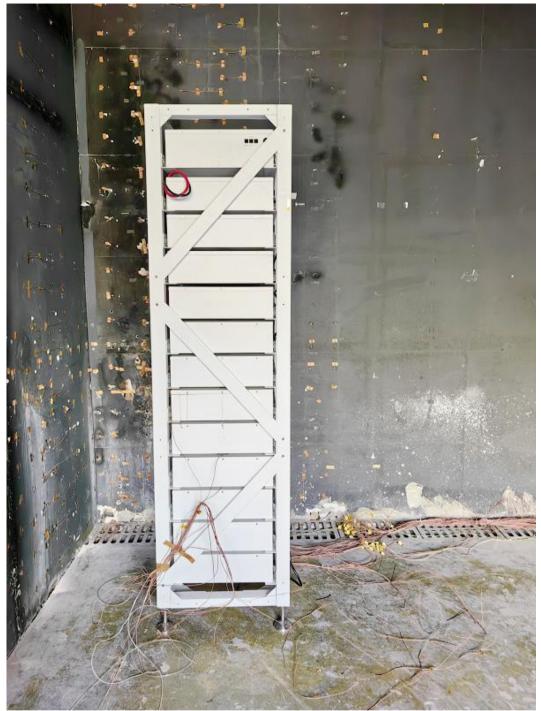
Figure 17. Photo 01 of initiating BESS unit after test.

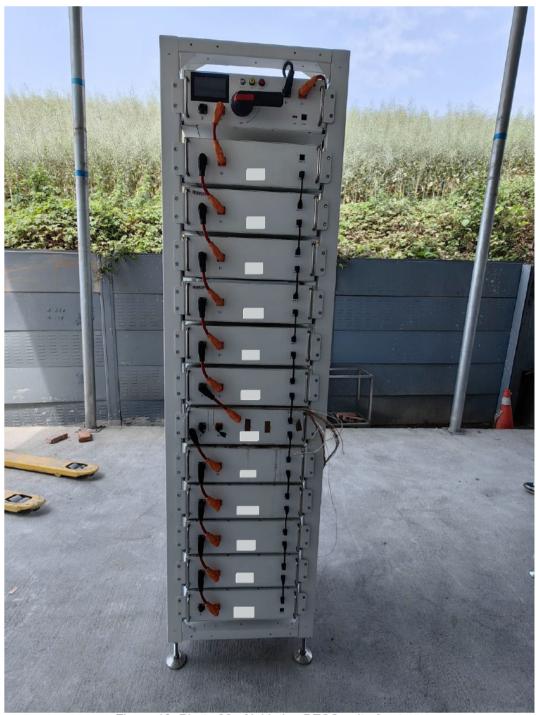
Figure 18. Photo 02 of initiating BESS unit after test.

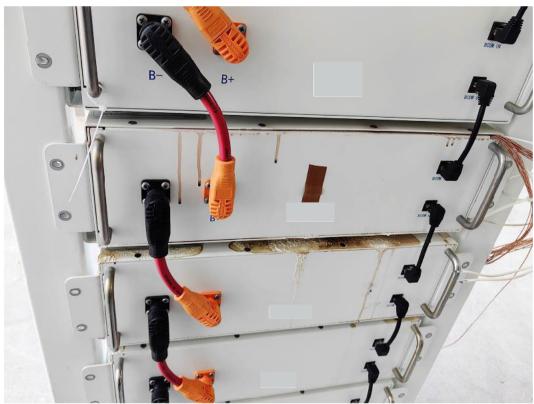
Figure 19. Photo 03 of initiating BESS unit after test

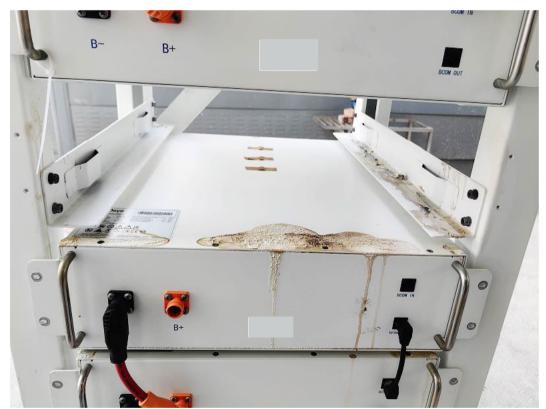
Figure 20. Photo 04 of initiating BESS unit after test.
